# Belzona Repairs Cracked Head

ID: 8593

**Industry:** Chemical & Petrochemical  
**Application:** TCC-Tanks and Chemical Containment Areas  
**Substrate:** Stainless Steel  
**Products:** \* Belzona 1511 (Super HT-Metal) ,  
\* Belzona 1983 ,  
\* Belzona 9381 (SWII reinforcement sheet) ,  
\* Belzona 1593 ,

**Customer Location:** Houston  
**Application Date:** 2019

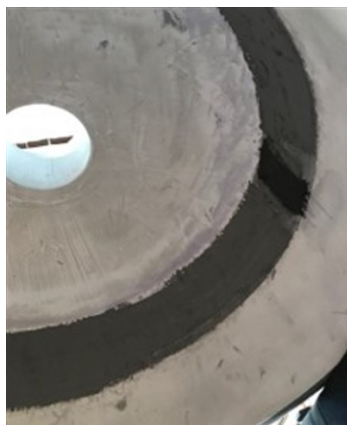
- \* 1. Cracks found with dye penetrate ,
- \* 2. 1st coat of Belzona 1593 and internal SW II after sweep blast ,
- \* 3. External SuperWrap II ,
- \* 4 Final coat of Belzona 1593 ,

A stainless steel head to a pressure vessel has a hairline crack along a weld.

Cracks were found using dye penetrate. All cracks were terminated, holes drilled and tapped 3/8" deep, and set screws installed. Belzona 1511 was used to flush out and rebuild the circumferential weld. Belzona SuperWrap II was applied on both the internal and external surface as a 6 layer system. Belzona 1593 was applied to the internals as a 2 coat system for additional protection.
