# BELZONA REFURBISHMENT OF EBARA SEA WATER PUMP

ID: 6050

**Customer Location:** Petrochemical Company, Saudi Arabia  
**Application Date:** November 2014

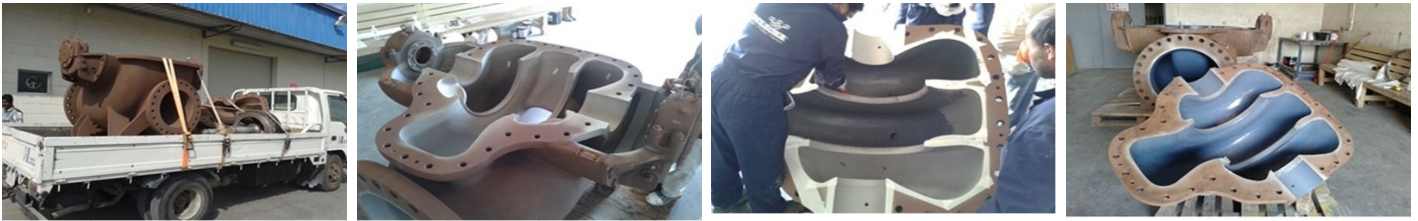
Severe corrosion and erosion on internal surfaces from operation with sea water.

- \* Before blasting ,
- \* After grit blasting ,
- \* Rebuilding with Belzona 1311 ,
- \* After coating with Belzona 1321 ,

Application was carried out in accordance with Belzona Know-How System Leaflets CEP-1 and CEP-3.
