# Multistage pump gets the Belzona treatment

ID: 7751

Industry: Fluid Flow  
Application: CEP-Centrifugal Pumps  
Substrate: Carbon Steel  
Products: \* Belzona 1111 (Super Metal) ,  
\* Belzona 5821 ,

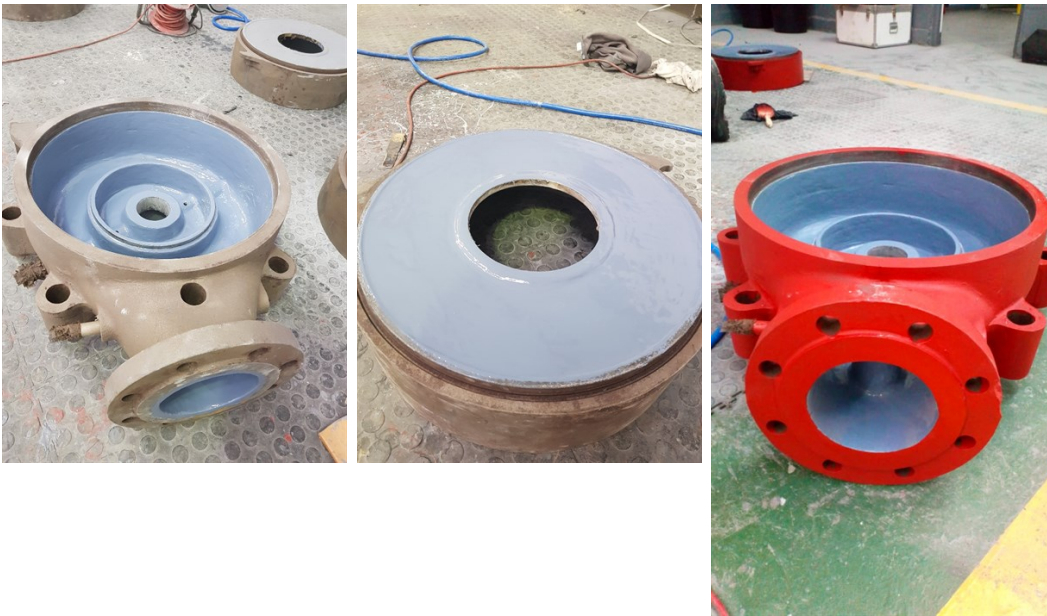
*During routine maintenance some signs of mild impingement erosion and corrosion, leading a small amount of wall loss, was identified.*

\* 1 - Damaged Pump prior to application 2 - Repaired and coated casing 3 - Repaired and coated end cover 4 - Completed application ready for re-assembly ,

Application was carried out in accordance with System Leaflets CEP-05 and CEP-03.

The customer requested a coating to reduce overall maintenance requirements and increase time between routine shutdowns. A number of coatings were considered, but Belzona 5821 gave the best balance between cost and performance for the light erosion resistance required. Re-building was required prior to the application of the coating. Instead of conventional weld repair Belzona 1111 was selected due to ease of application (no machining required) and compatibility with the Belzona coating.
